- UPPER LAKE MINNIE HA-HA DAM,
- LOWER LAKE MINNIE HA-HA DAM,
- LAKE MINNIE HA-HA DEVELOPMENT,
- STE. GENEVIEVE COUNTY, MISSOURI .

PHASE 1 INSPECTION REPORT. NATIONAL DAM SAFETY PROGRAM.

DECEMBER 1979

UPPER LAKE MINNIE HA-HA DAM - ID. NO. 30643

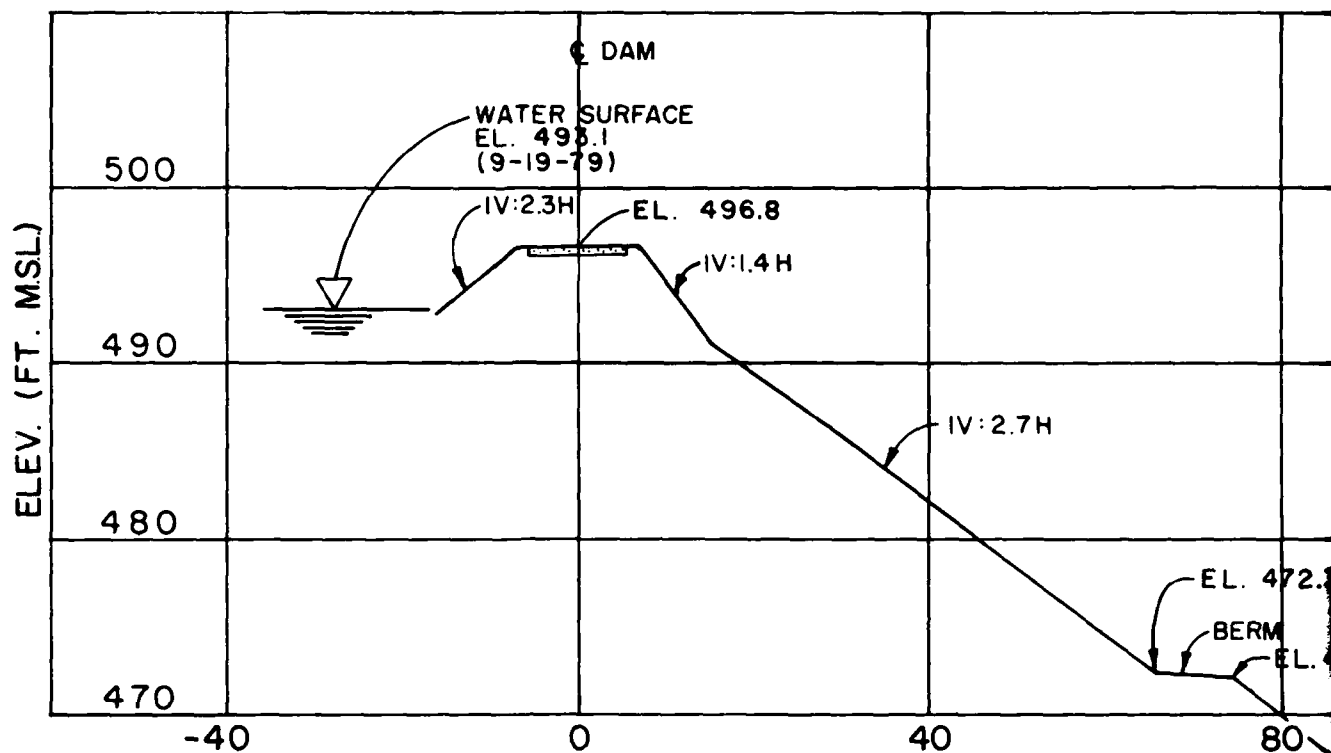
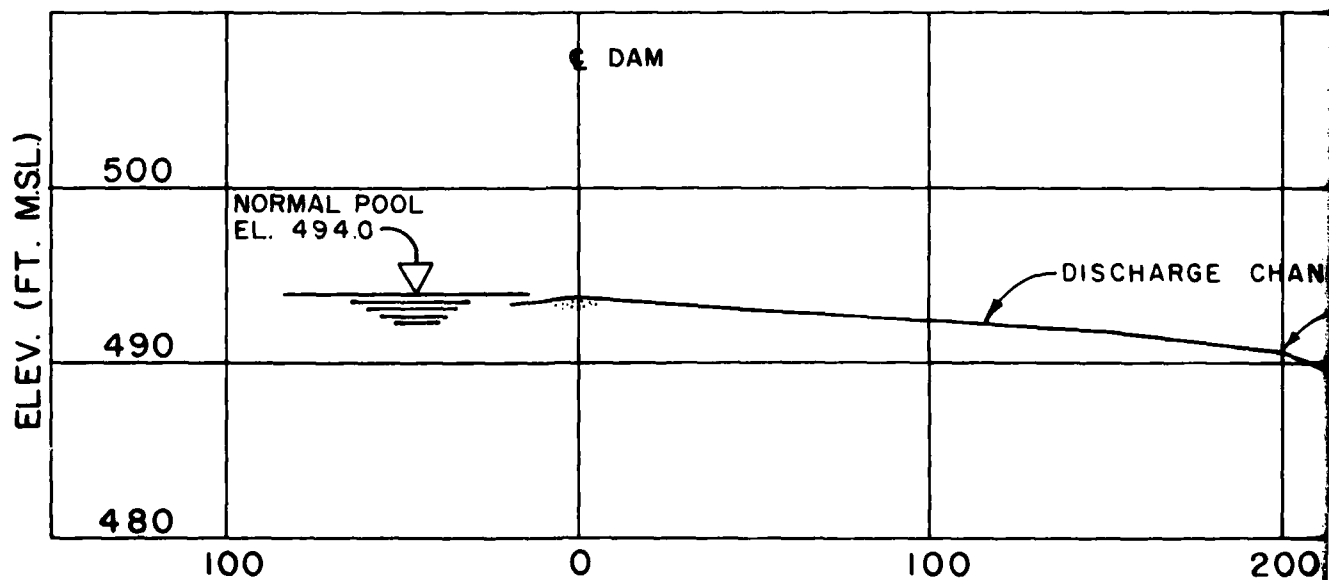
PLATE 4

(1) Upper Lake Minnie Ha-Ha Dam. The Upper Lake Minnie Ha-Ha Dam is an earthfill type embankment rising approximately 39 feet above the original streambed. The embankment has an upstream slope (above the waterline) of 1v on 2.3h, a crest width of about 14 feet, and an irregular downstream slope that varies from 1v on 1.4h to 1v on 2.7h. A 9-foot wide berm is located near the downstream toe. The length of the dam including the spillway section is approximately 694 feet. A road surfaced with gravel traverses the dam crest. A plan and profile of the dam is shown on Plate 3 and a cross section of the dam is shown on Plate 4.

The spillway, a broad-crested trapezoidal weir section, is located at the east or left abutment of the dam. The road traversing the dam crest crosses the spillway crest. The spillway discharge channel directs flow away from the downstream face of the dam. A berm that serves to protect the embankment is provided between the channel and the downstream face of the dam. The upper portion of the spillway discharge channel, a grass lined trapezoidal section, is cut into the hillside to an intersection with a ravine that in turn flows into Lower Lake Minnie Ha-Ha. The lower reach of the excavated channel adjacent to the ravine is steep and deeply eroded to bedrock. Old tires and discarded machinery have been placed in the lower areas of the channel in an attempt to control further erosion. A profile of the spillway discharge channel is shown on Plate 4.

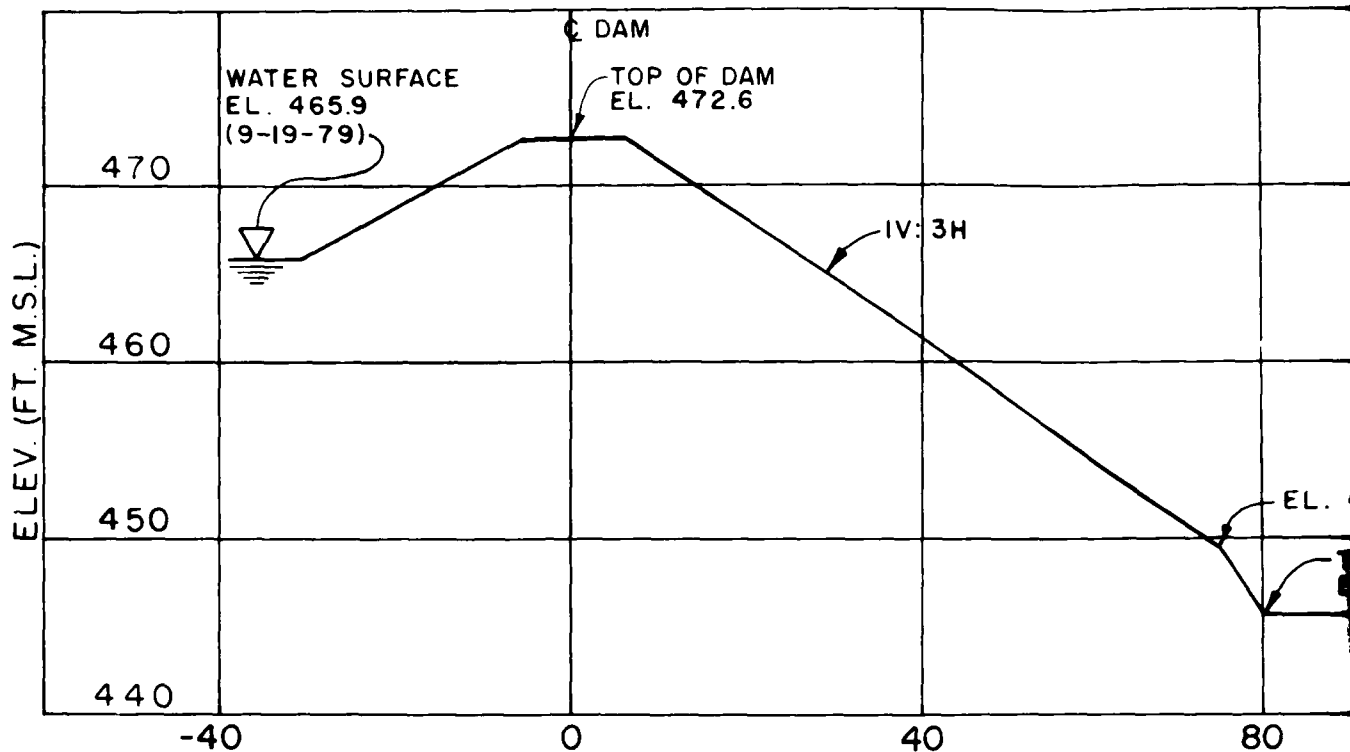
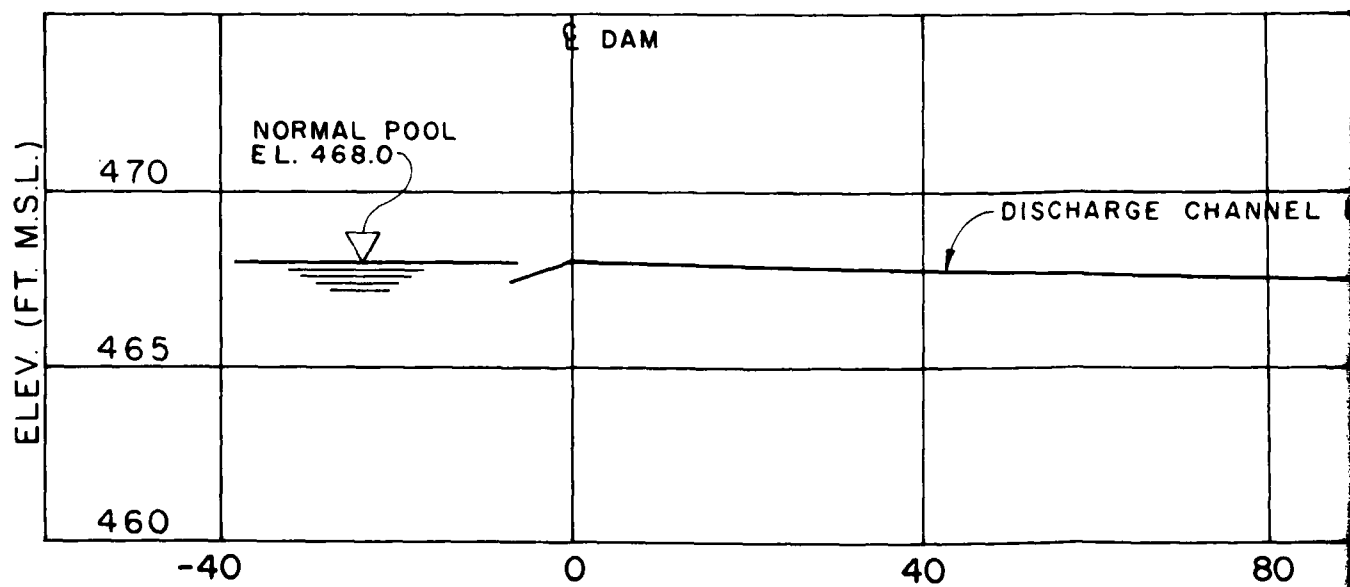
PLATE 6

(2) Lower Lake Minnie Ha-Ha Dam. The Lower Lake Minnie Ha-Ha Dam is an earthfill type embankment rising approximately 27 feet above the original streambed. The embankment has an upstream slope (above the waterline) of 1v on 3.9h, a crest width of about 12 feet, and a downstream slope of about 1v on 3h. The length of the dam including the spillway is approximately 426 feet. A plan and profile of the dam is shown on Plate 5 and a cross-section of the dam is shown on Plate 6.

The spillway, a broad-crested trapezoidal weir section, is located at the east or left abutment of the dam. The spillway discharge channel, a grass lined trapezoidal section, conducts flow away from the dam. The channel is cut into the hillside with a protective berm between the channel and the downstream face of the dam. The discharge channel extends downstream to an intersection with a ravine that joins the original stream channel. The lower portion of the spillway channel adjacent to the ravine is steep, and rock riprap has been provided at this location to control erosion. A profile of the discharge channel is shown on Plate 6.
